Report No.: B24060512
Date Reported: 06/28/2024
P.O. No.: Pre-Paid

Sample Description: Hail Damaged Roof Panels (5).

Forensic Investigation of Metal Roof Panels Reportedly Damaged in a Hail Storm

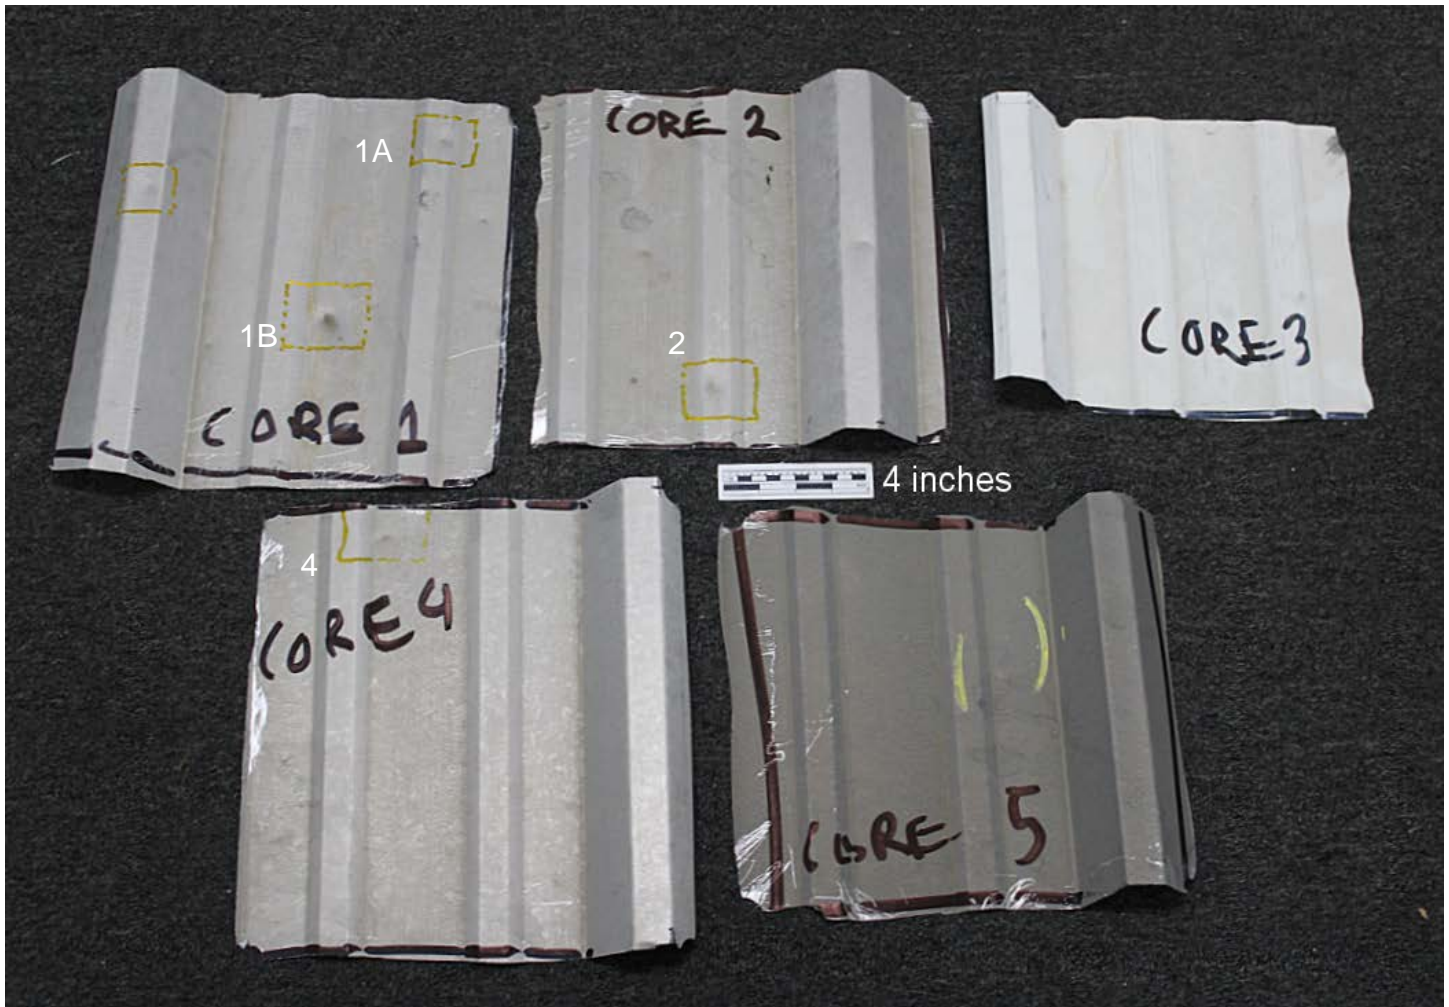
The hail impact points on the submitted roof panels (Figure 1) each exhibited corrosion products in the approximate center of each damage location. These corrosion products were visually evident without the use of a microscope and they all exhibited optically reddish-brown appearance. The impact points were carefully extracted (Figure 2) for evaluation.

Figure 1: Optical image of the damaged roof panels displayed in the as-received condition. Hail impact points are indicated (yellow paint pen).

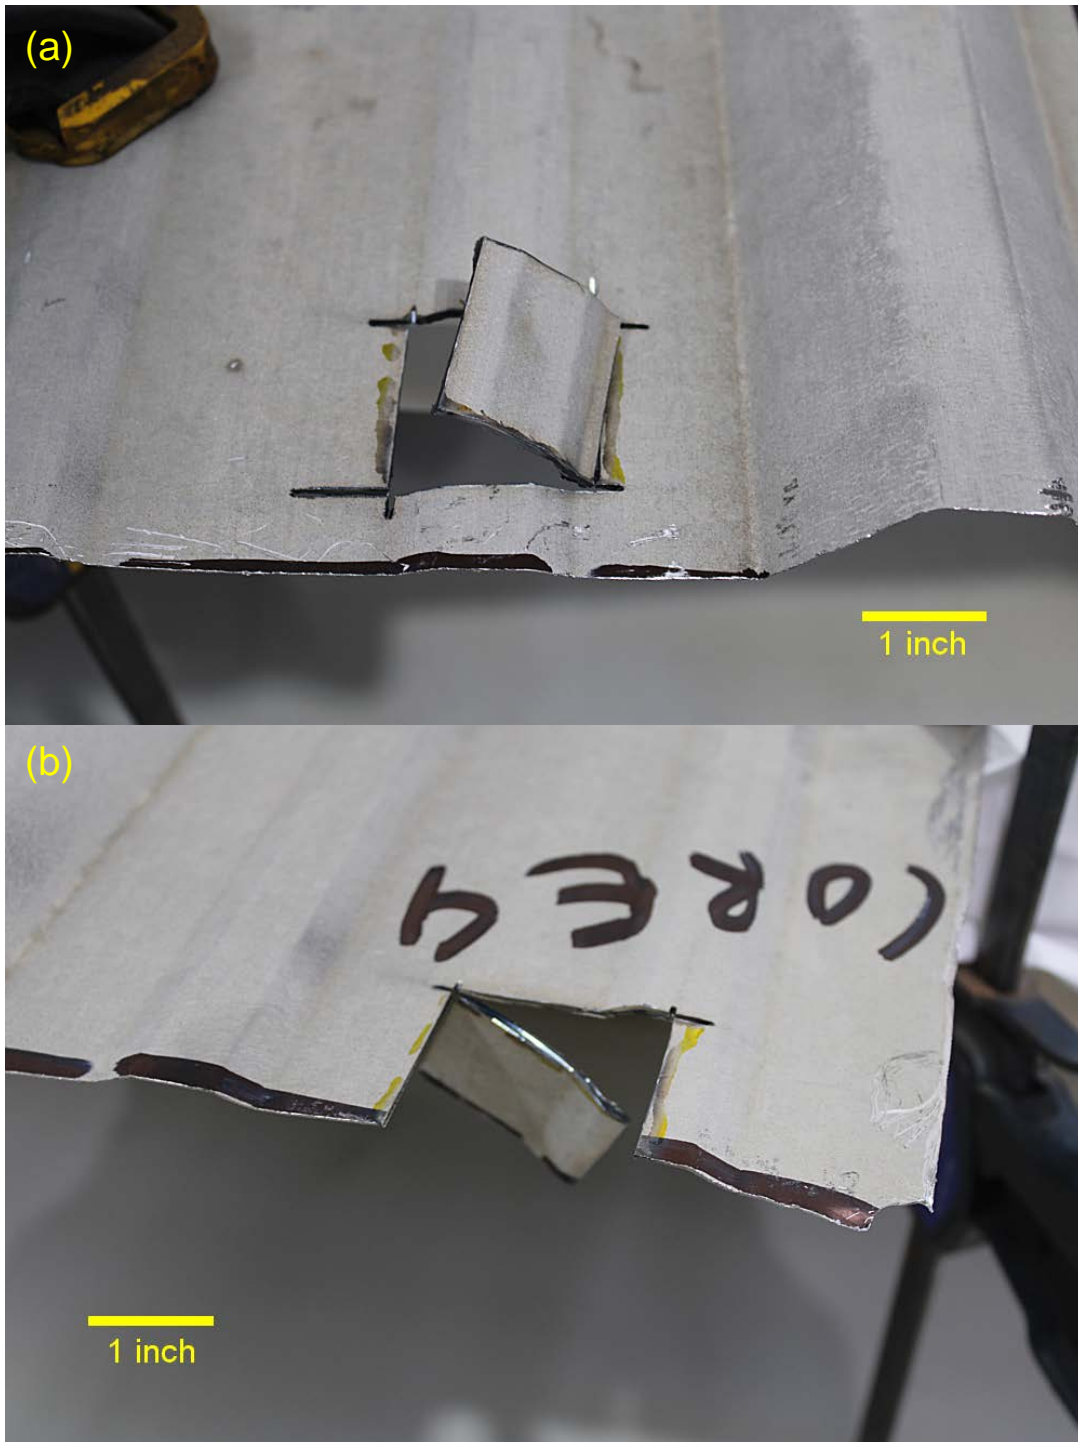
Figure 2: Optical images (a, b) showing the specimen extraction process employed to acquire specimens specifically at hail impact points. This process eliminates specimen preparation artifact as neither surface exhibiting damage is touched during extraction.

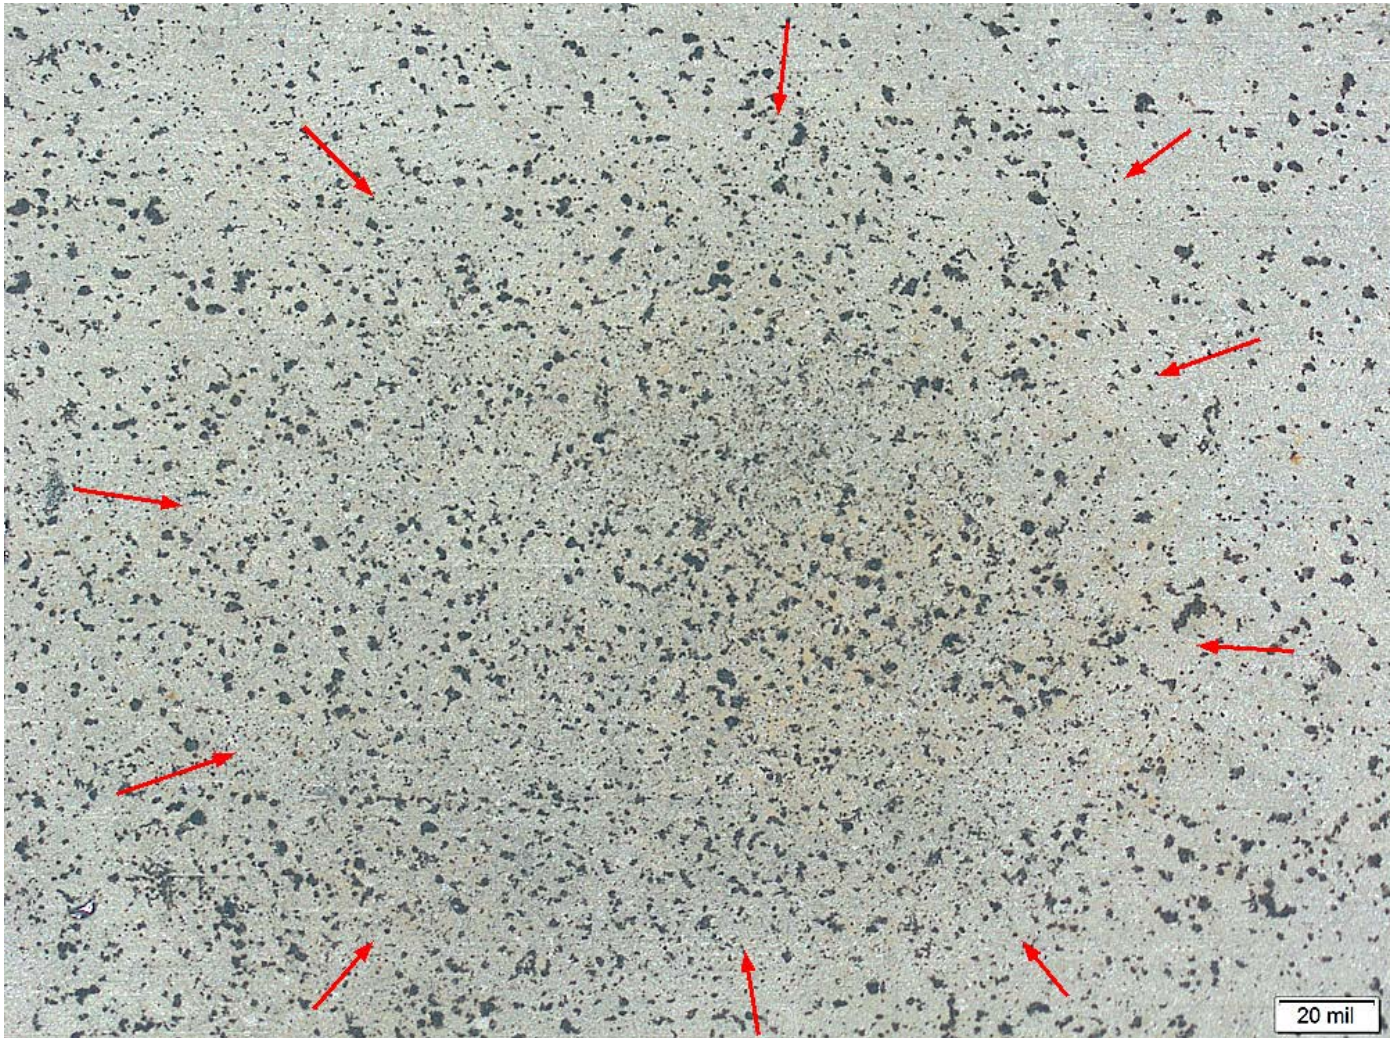
All of the hail impact points (Figure 3) exhibited relatively circular depressions with the center of each impact point deeper than the surrounding perimeter(s). Reddish brown corrosion products (Figure 4 yellow ellipses) were heavily concentrated at these impact points. Location 1B of roof panel No.1 (Figure 5) exhibited a very large depression and the entire depression exhibited evidence of elevated corrosion products. The impact point was so large that damage most likely occurred due to hail over 1" in diameter. The center of this point was so deep that impact perimeter(s) were heavily defocused (Figure 6). Localized corrosion products were characteristic of all impact points that were analyzed across multiple roof panel samples.

Figure 3: Stereo optical microscope image representative of the impact point of damage on roof panel No.1 impact point 1A (Figure 1). The scale bar is in mils (0.001").

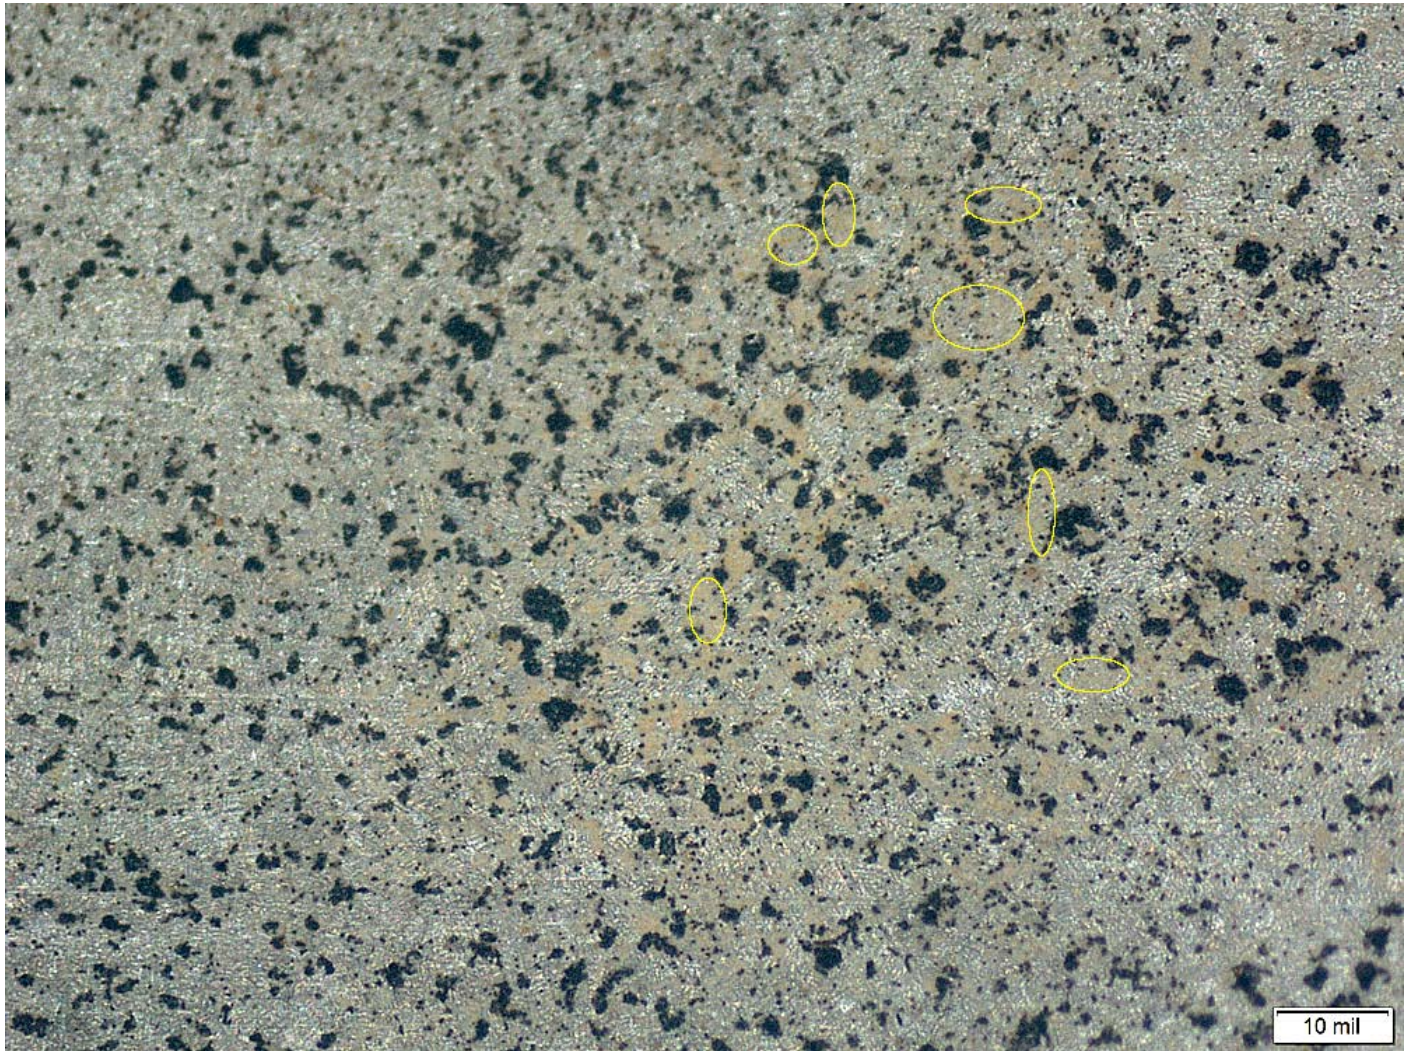
Figure 4: Stereo optical microscope image showing the center of the hail impact point damage on roof panel No.1; impact point 1A (Figure 1). The scale bar is in mils (0.001").

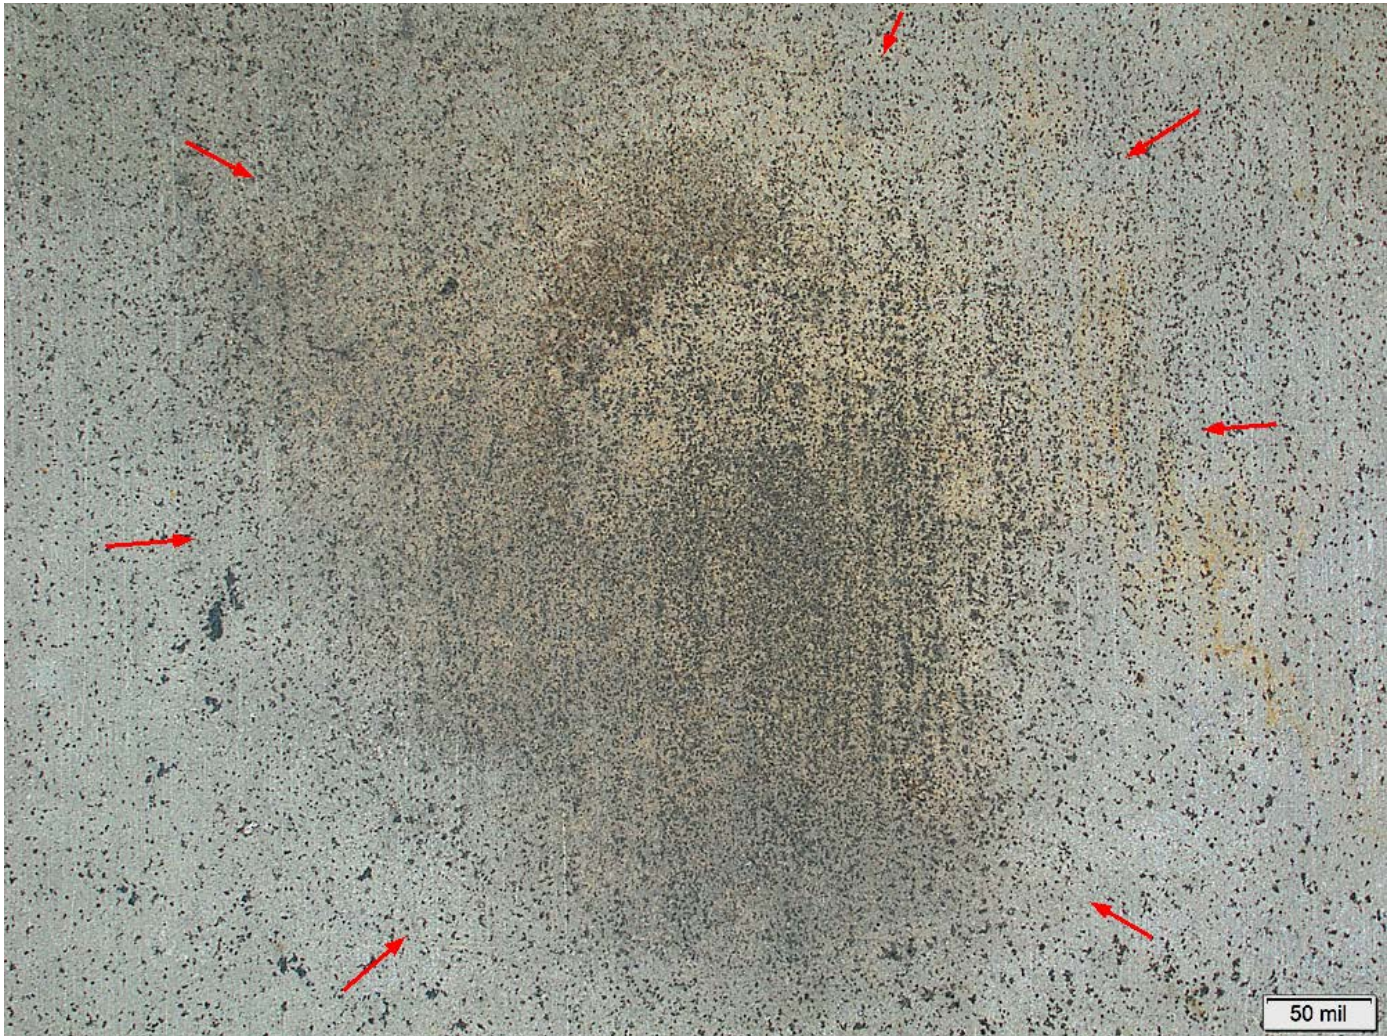
Figure 5: Stereo optical microscope image representative of the impact point of damage on roof panel No.1 impact point 1B (Figure 1). The scale bar is in mils (0.001”).

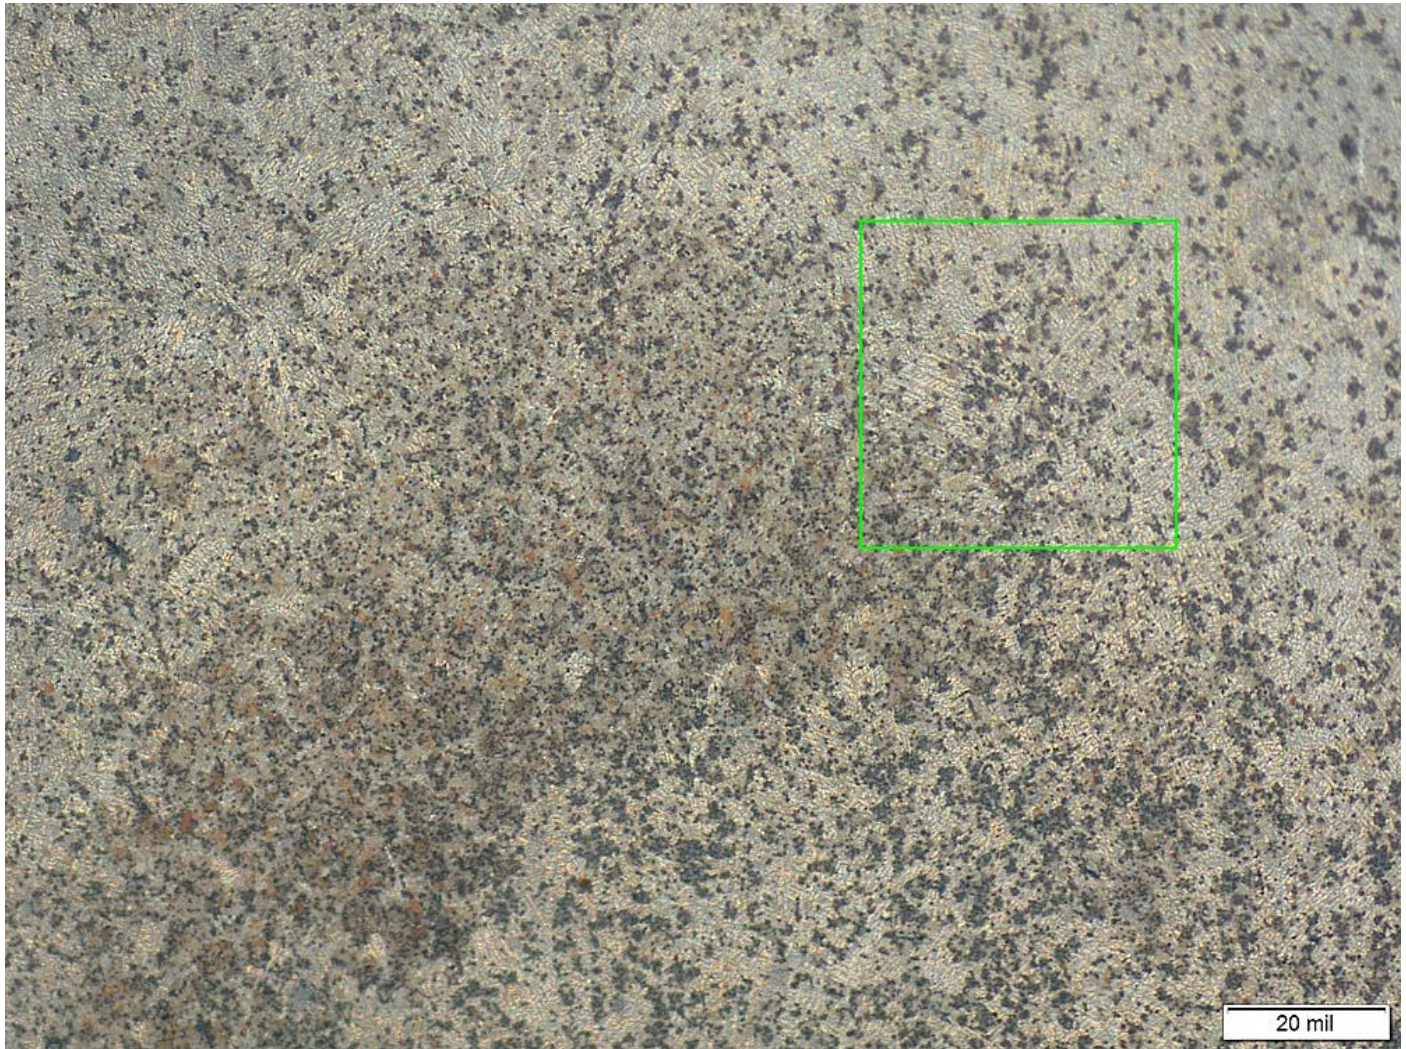
Figure 6: Stereo optical microscope image representative of the impact point of damage on roof panel No.1 impact point 1B (Figure 1). The scale bar is in mils (0.001").

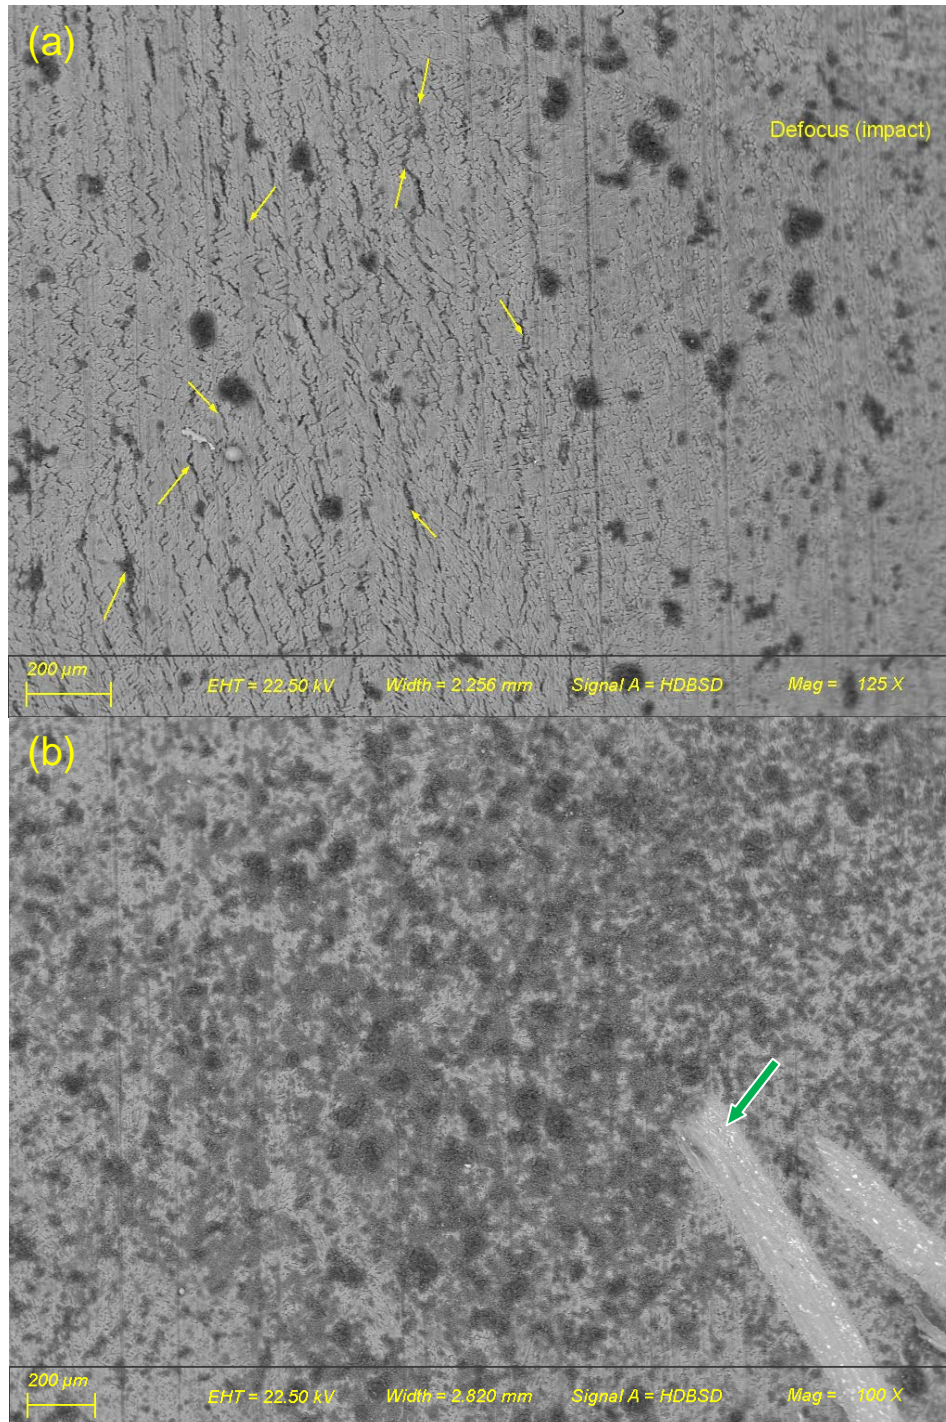
In addition to localized corrosion within the center of hail impact points, the adjacent region(s) slightly offset from each point of impact were frequently micro-cracked due to bending (Figure 7a yellow arrows). The center of these impact points, which were precisely marked (green filled arrow) under the stereoscope (Figure 7b), exhibited evidence of heavily concentrated corrosion products. Closer inspection confirmed the presence of iron oxides that were frequently formed as agglomerates along micro-cracks in the Galvalume® protective layer (Figure 8). Moving towards the heaviest agglomerates confirmed that elevated iron oxides compared to the background (Figure 9) were also present, even in areas where top coat material remained. Moving to other points of hail damage (Figure 10) again confirmed that heavy agglomerates of corrosion products were present and the central as well as perimeter (Figure 11) regions exhibited iron oxides (*i.e.* rust). Finally, evaluation of many locations confirmed that aqueous phase formation and growth through the Galvalume® occurs with the result being formation of heavy concentrations of iron oxide (Figure 12). Based upon these analyses, there can be no question that both migration of Fe from the base metal through the protective panel coating(s), as well as the rapid oxidation of Fe to form rust, occurs specifically in the center of hail damage locations.

Figure 7: Backscattered electron (BSE) images representative of the impact point on roof panel No.1 at damage location 1A (Figure 1). The scale bars are in microns (μm). Scribe marks intentionally cut prior to the EM protocol are indicated (green filled arrow).

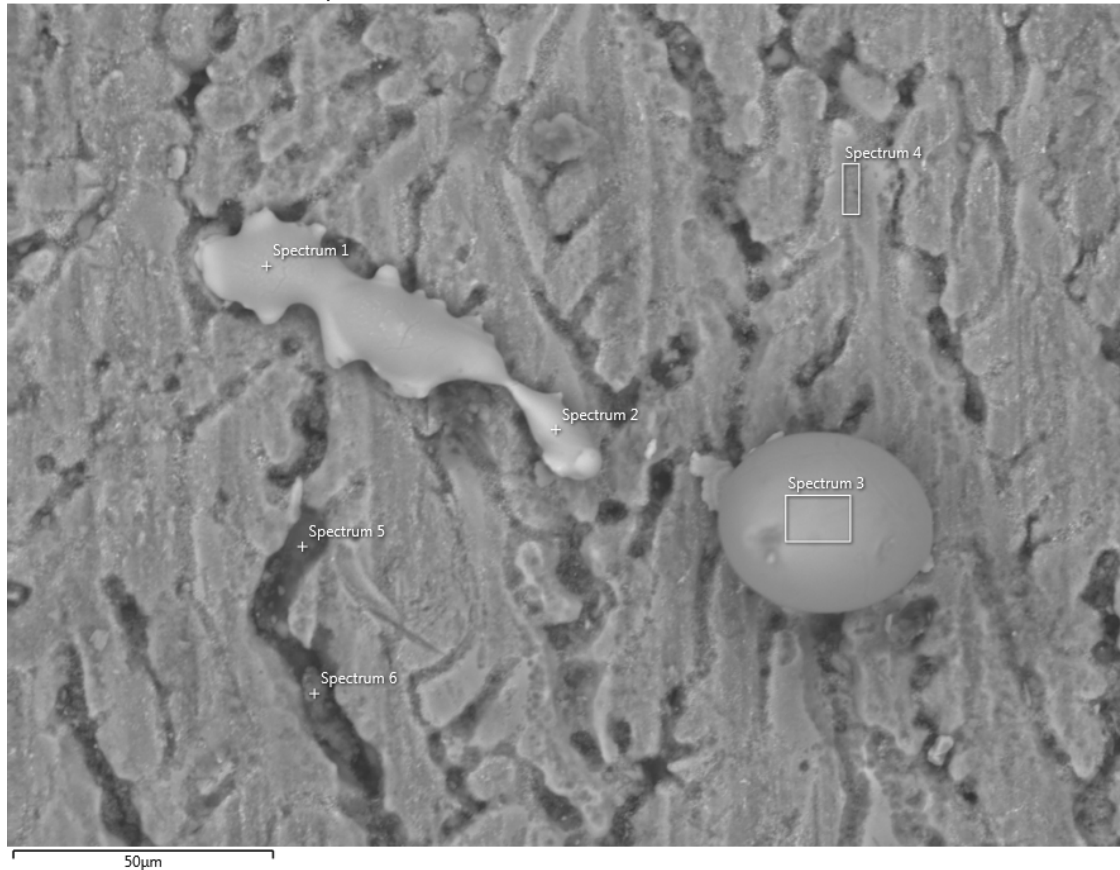
Impact Point, Localized Corrosion, Iron Oxide(s), No.1A, ROI 1

Figure 8: BSE image showing localized iron based corrosion products situated within the impact point of roof panel No.1 at damage location 1A, along with semi-quantitative EDS data (table) that were generated from the focused probe locations identified in the image.

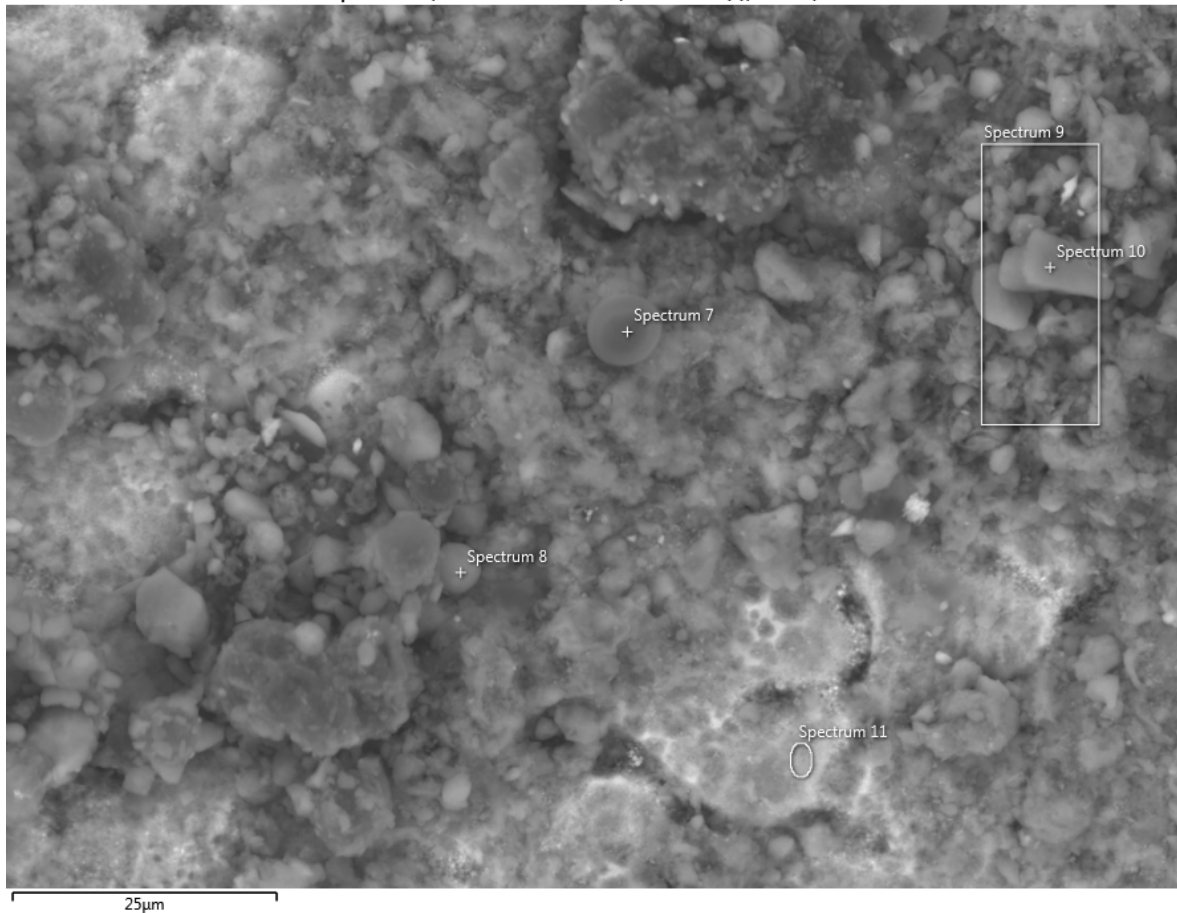
Impact Point, Localized Corrosion, Iron Oxide(s), No.1A, ROI 2

Figure 9: BSE image showing localized iron based corrosion products situated within the impact point of roof panel No.1 at damage location 1A, along with semi-quantitative EDS data (table) that were generated from the focused probe locations identified in the image.

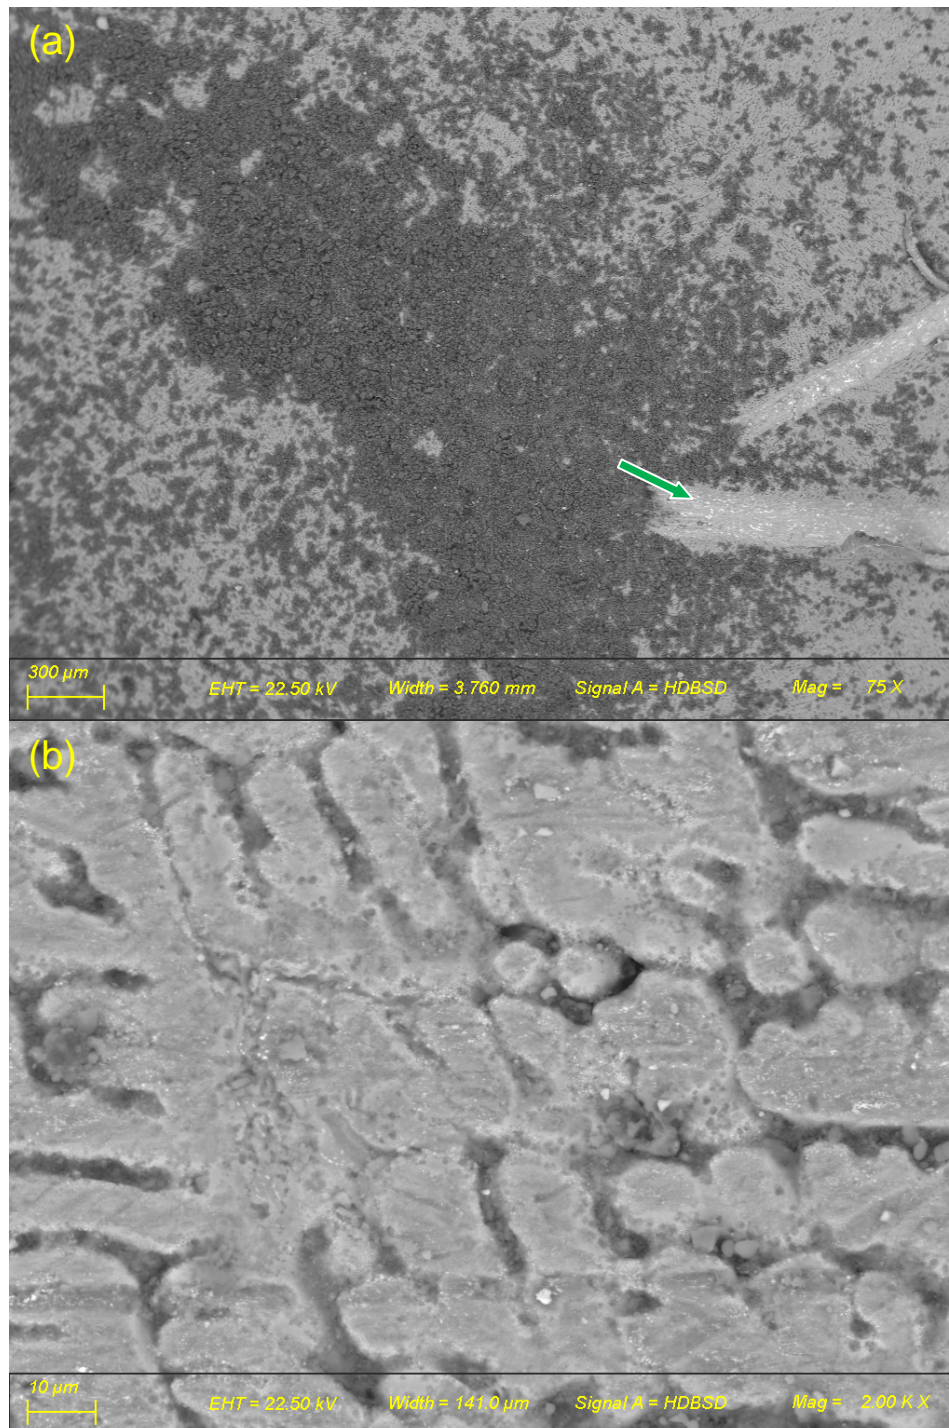
Figure 10: Backscattered electron (BSE) images representative of the impact point on roof panel No.1 at damage location 1B (Figure 1). The scale bars are in microns (μm). Scribe marks intentionally cut prior to the EM protocol are indicated (green filled arrow).

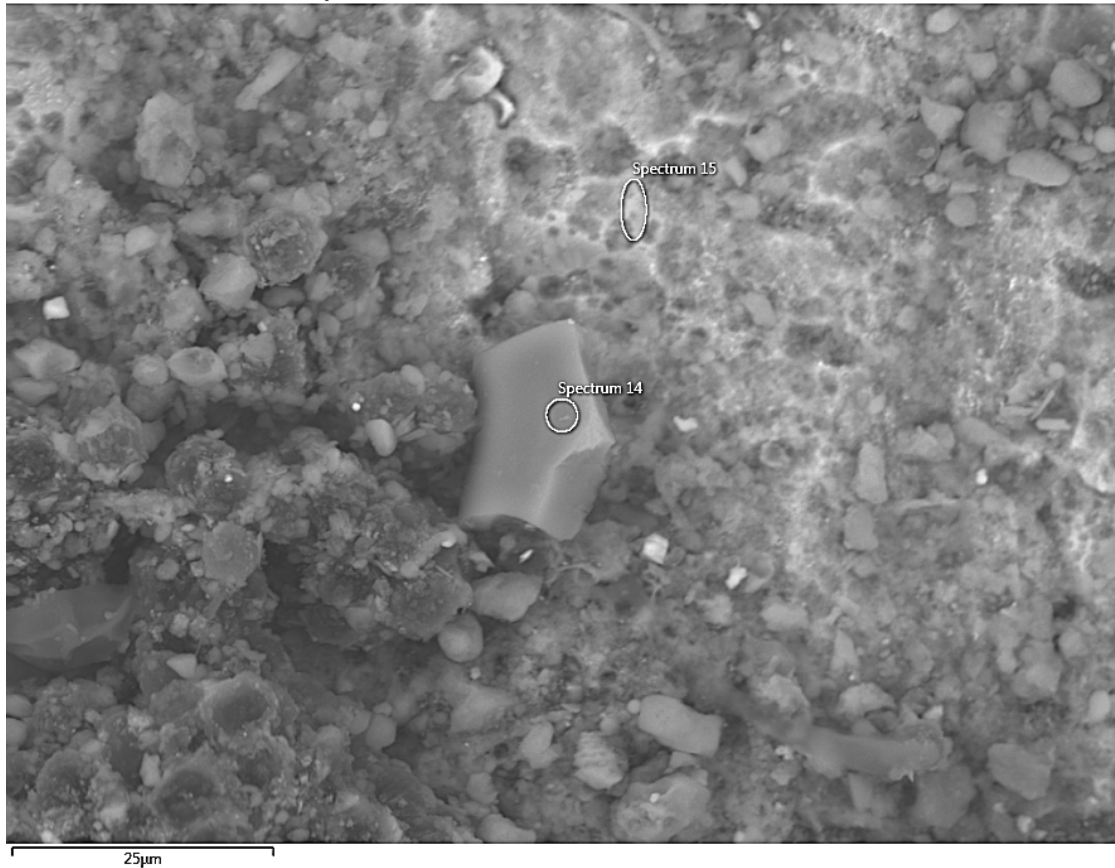
Impact Point, Localized Corrosion, Iron Oxide(s), No.1B, ROI 1

Figure 11: BSE image showing localized iron based corrosion products situated within the impact point of roof panel No.1 at damage location 1B, along with semi-quantitative EDS data (table) that were generated from the focused probe locations identified in the image.

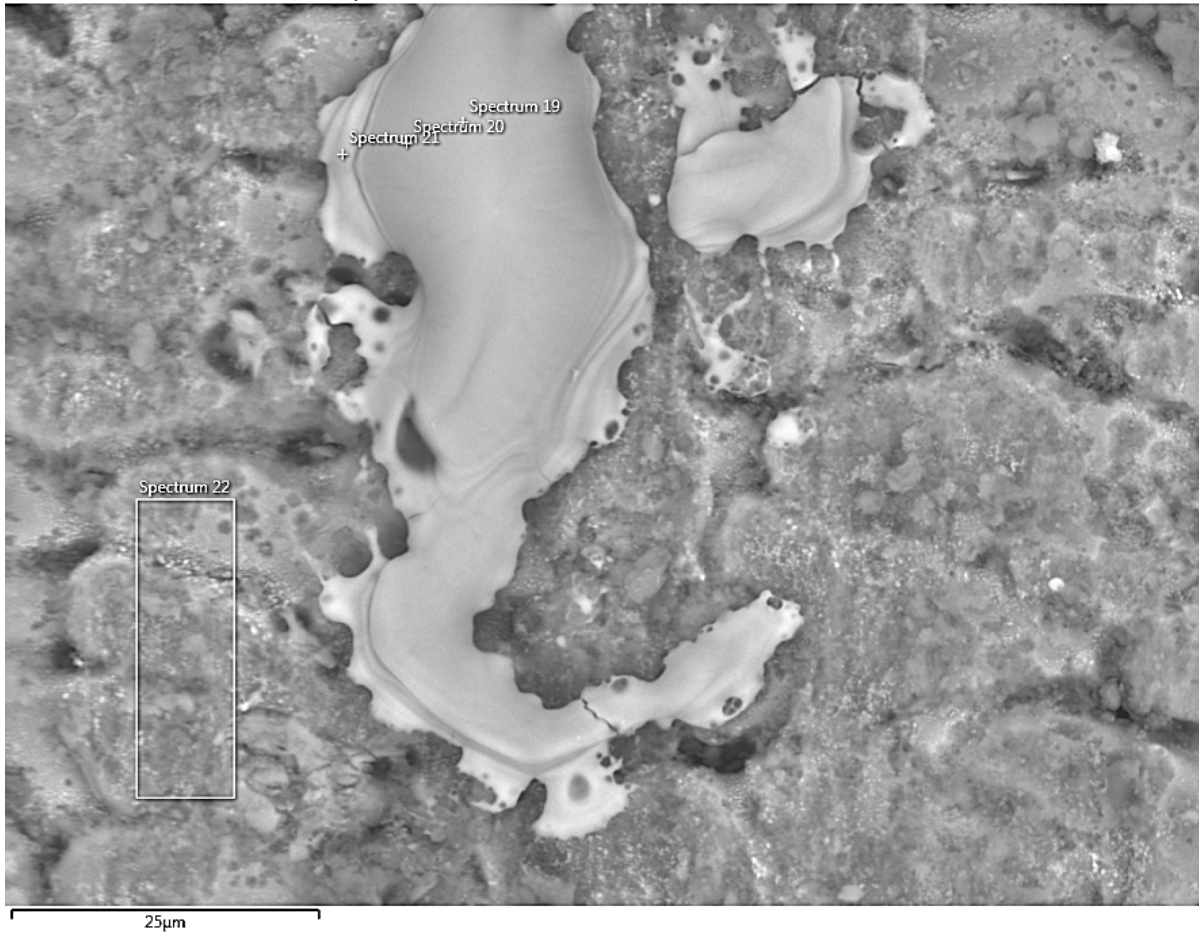
Impact Point, Localized Corrosion, Iron Oxide(s), No.2, ROI 1

Figure 12: BSE image showing localized iron based corrosion products situated within the impact point of roof panel No.2, along with semi-quantitative EDS data (table) that were generated from the focused probe locations identified in the image.
